Inside

IMPROVED THREE SECOND DELAYED START RETROFIT

BULLETIN RELEASE NO. 114

BULLETIN RELEASE NO. 115

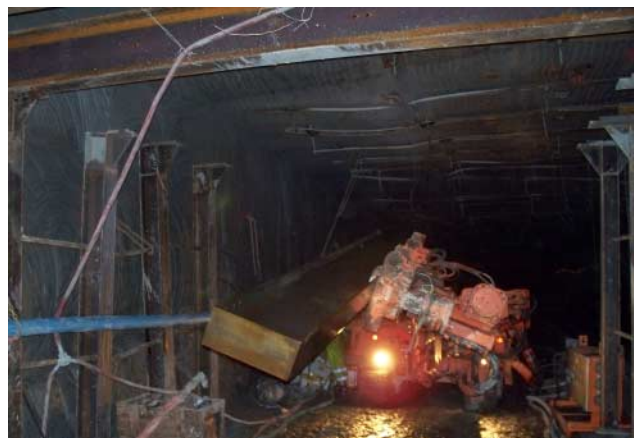
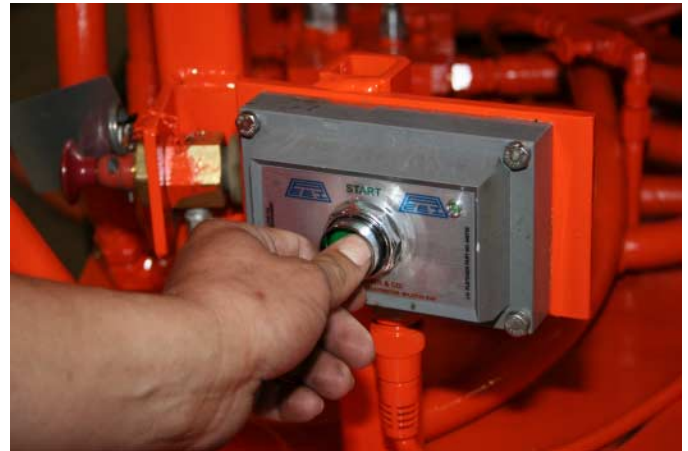
During the past year a few of our customers have experienced trouble with the three second delayed start device. Since 2006, J.H Fletcher & Co. permissible AC roof bolters have been equipped with this device. The addition of this timer results in the machine having a “jog” function: immediate starting, but releasing the “start” button stops the motor.

In order to prevent any bypassing of this device or an interruption in operation, J.H. Fletcher & Co. has now worked with our vendor to develop an improved delay start device. We believe the new timer will provide more reliable service in the mining environment.

Basically, we have used two different relays to perform this function. Initially P/N 124418 relay was used, which was later replaced with P/N 124991. In either case, one relay per motor was required.

Should a replacement relay, either 124418 or 124991 be requested, the following must be determined.

Has the machine been modified using the Timer Upgrade Kit?

If **NO**, then the appropriate upgrade kit should be provided.

P/N 125810 – Timer Upgrade Kit, Single Motor Machine

P/N 125811 – Timer Upgrade Kit, Dual Motor Machine

If **YES**, then all that is required is a replacement P/N 125822 relay assembly.

If your 3 second timer is operating properly now, there is no need to replace the timer. However, if you are experiencing any kind of problem, please order the components from J.H. Fletcher & Co. or one of our authorized parts distributor.
