J. H. Fletcher & Co.

2010 Issue 1

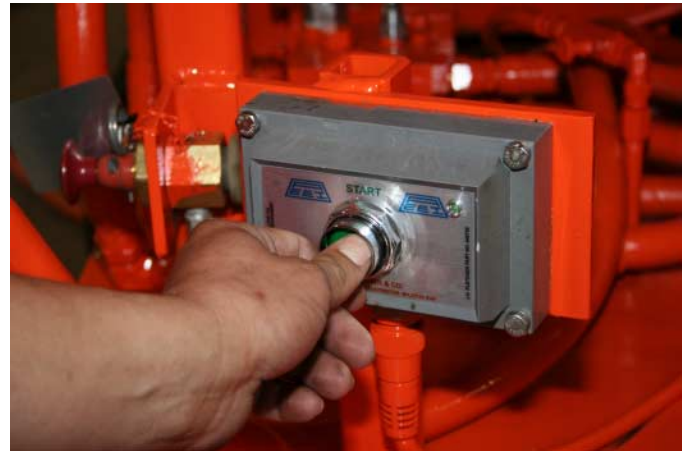
During the past year a few of our customers have experienced trouble with the three second delayed start device. Since 2006, J.H Fletcher & Co. permissible AC roof bolters have been equipped with this device. The addition of this timer results in the machine having a “jog” function: immediate starting, but releasing the “start” button stops the motor.

Basically, we have used two different relays to perform this function. Initially P/N 124418 relay was used, which was later replaced with P/N 124991. In either case, one relay per motor was required.

Has the machine been modified using the Timer Upgrade Kit?

If **NO**, then the appropriate upgrade kit should be provided.

P/N 125810 – Timer Upgrade Kit, Single Motor Machine

P/N 125811 – Timer Upgrade Kit, Dual Motor Machine

If **YES**, then all that is required is a replacement P/N 125822 relay assembly.

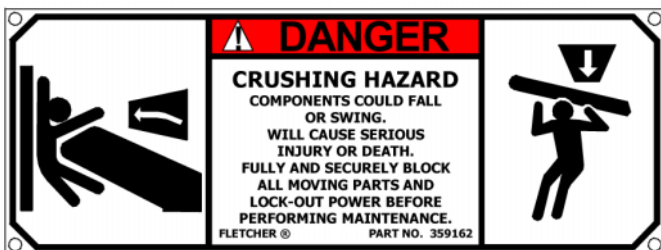
warnings clear and concise. Fletcher now has available tag number 359162 as a replacement for 159538. This danger notice alerts maintenance personnel to securely block all moving parts and lock-out power before performing maintenance. (If you would like to receive this tag, contact the Fletcher service department.)

Fletcher reminds all personnel, operating or working on Fletcher equipment, that maintaining warning, caution and danger tags is just as important as maintaining the machine. Keep tags clean and legible and order replacements from Fletcher when necessary.

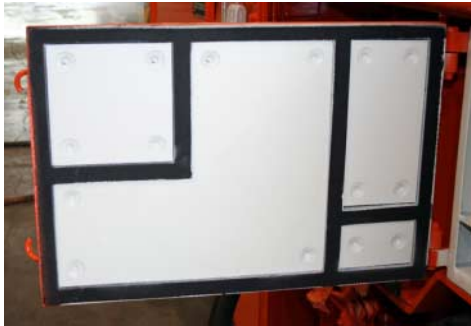
A dust box gasket provides a vacuum seal on the dust tank. When the gasket wears out, the maintenance personnel must replace the gasket with the proper material to help maintain adequate vacuum in the dust collection system. J.H. Fletcher & Co. now has a repair kit for the dust tank(s) seal. Call the Fletcher Service Department with your machine serial number and they can provide the correct replacement kit. The kit includes a brush, gasket and resin. We recommend that you provide this information to all component purchasers and maintenance personnel.

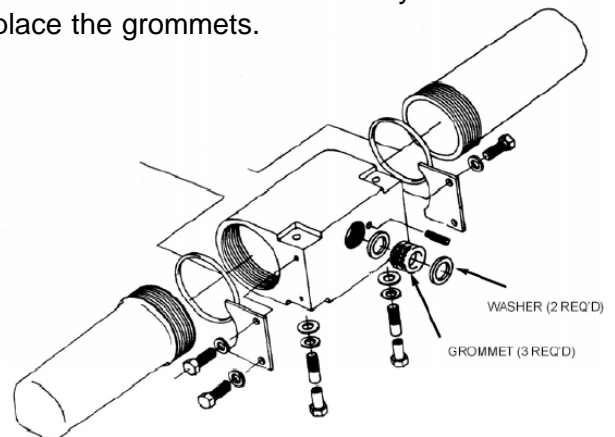
In February 2010, J.H. Fletcher & Co was notified by our vendor, Mining Controls Inc. (MCI), that the light packing glands distributed by MCI in the time period of July 24, 2009 through November 25, 2009 may be undersized. Fletcher has found that these glands were used in specific machines over the last year only. In an effort to assist our customer with the MCI notification, J.H. Fletcher & Co. will provide grommets free of charge for these specified machines. If you own one of these machines, Bulletin No. 115 is being sent to you. Please review this document and contact Fletcher if you decide to replace the grommets.
