# Fletcher

Product  
Newsletter

September 1997

Information  
Bulletin  
No. 70

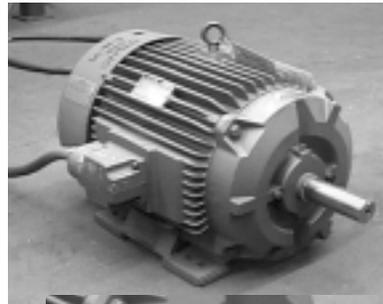
Although the various electrical enclosures (electric motor, lights, starter box, etc.) are permissible - they are not waterproof. During operation the electric motors, lights and starter box will generate heat. If cold water is sprayed onto these components while they are still hot the air inside will be cooled which will create a vacuum that can draw water inside the component.

**Do not direct high pressure spray to the base of the shaft**

Electric motors suffer the greatest damage. Water is drawn in around the shaft and into the bearings, corrosion and bearing failure soon follow. To prevent this problem, always allow the machine to cool before washing.

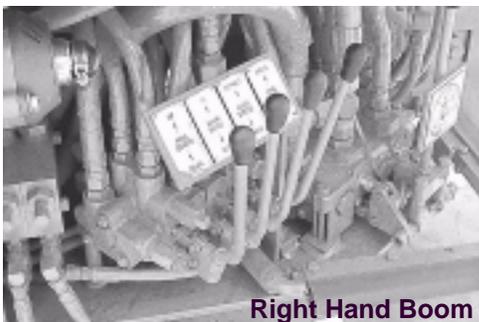
Although the Gresen valve bank performed adequately, the relatively small valve spools and control handle assemblies associated with this valve bank were felt to be a maintenance problem by some customers.

**Right Hand Boom**  
Gresen Valve

To eliminate these spool and handle assembly problems we decided to replace the Gresen valve bank with a Commercial valve bank which was integrated

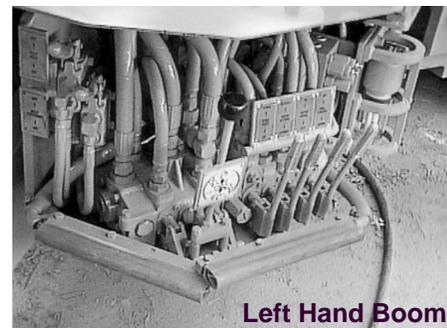
**Left Hand Boom**  
Commercial Valve

with the existing Commercial valve bank that controlled the drill feed and rotation.

Besides eliminating the spool and handle maintenance problems, this change also eliminated some of the hosing required in this area of the machine.

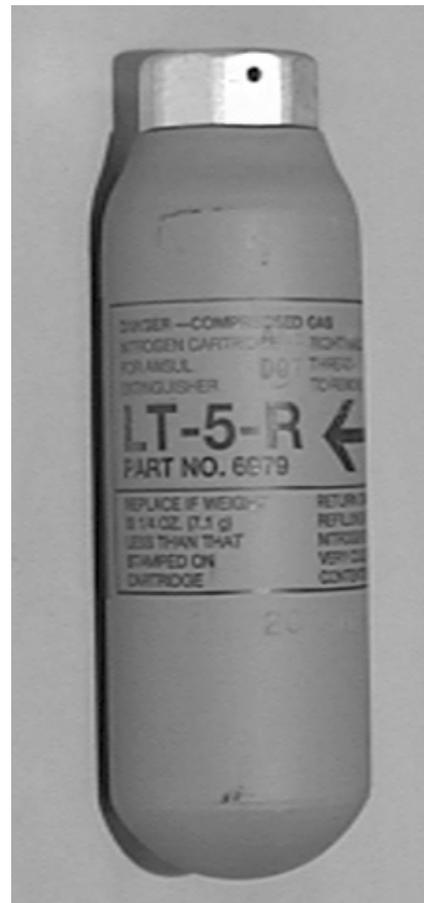
*ANSUL Cartridge*

Throughout the coal mining industry, gas (carbon dioxide or nitrogen) cartridges are utilized to activate the dry chemicals in fire extinguisher systems. To operate J. H. Fletcher & Co. fire extinguisher systems on our bolters, a nitrogen filled gas cartridge is discharged, usually at the operator's station. This system, if maintained properly, will extinguish a fire located on your equipment. However, the internal seal that prevents the nitrogen from escaping from the ANSUL cartridges could rupture unintentionally, without warning, if they are not installed or stored properly. This accidental activation (rupture) could result in serious injury or death. Therefore, J. H. Fletcher & Co. is reminding our customers that these cartridges are under extreme pressure and that care should be taken at all times during the installation and storage of these pressurized vessels.

J. H. Fletcher & Co. advises you to take steps to ensure all cartridges are stored separately; shipping caps are replaced on the cartridges when they are not attached to the fire extinguisher systems; and that no cartridge is stored at or near a high heat source (direct sunlight, welding, etc.). We advise you to reevaluate the use and storage policy in your shop and take immediate steps to ensure your employees are aware of and trained on the dangers of these small but highly pressurized cartridges. To assist you in your efforts to train your employees, ANSUL has provided J. H. Fletcher & Co. specific information (February 29, 1984, Section III System Components, Technical Bulletin Number 31 and Technical Bulletin Number 34).
