IMPORTANT RETROFIT NOTICE

INFORMATION BULLETIN NO. 67

TO: ALL OWNERS, OPERATORS, AND REBUILDERS OF J. H. FLETCHER & CO. RRII/DDO ROOF BOLTING EQUIPMENT

SUBJ: RETROFIT—PRESSURE SETTING ON RRII/DDO

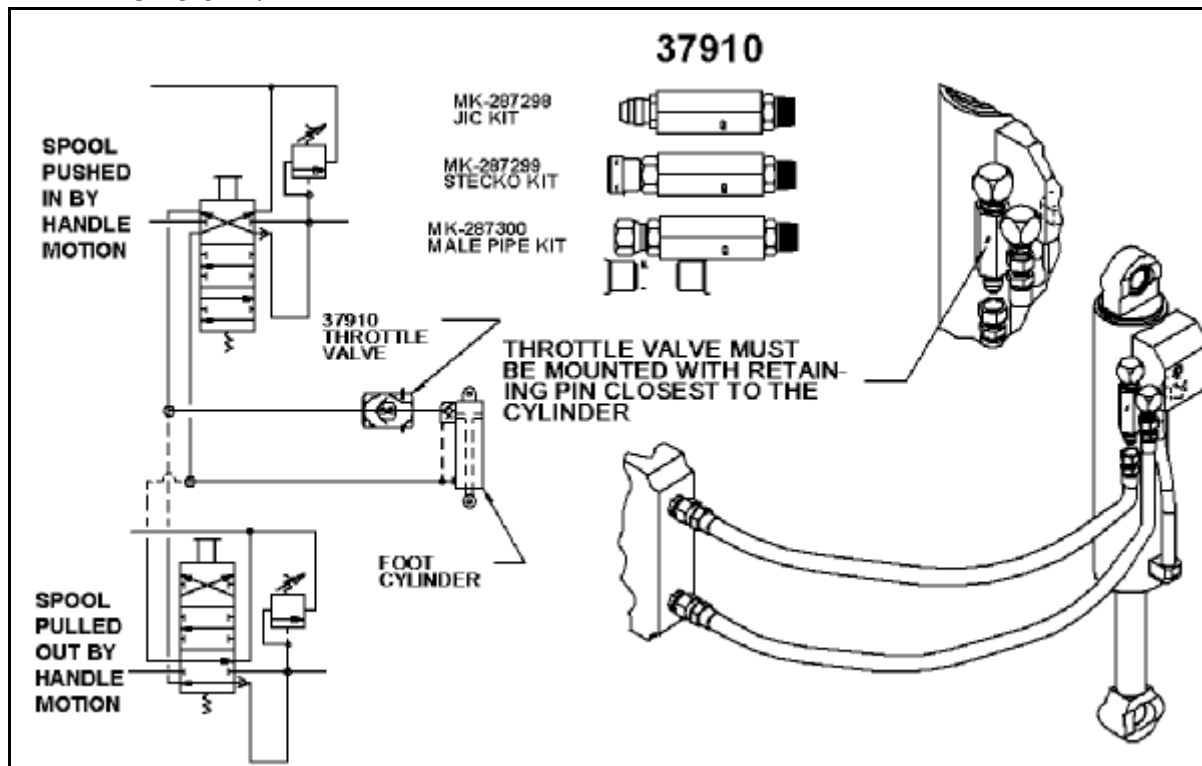
DRAWING 18-97-7/A

When investigating these accidents, it was found that the pressure in the foot jack circuit had been altered from the 500-700 psi setting specified by Fletcher. The alterations take place when the foot jack control valve is replaced or repaired and the correct relief valve and specified pressure settings are not maintained or the relief valve has been readjusted from the original OEM specified pressure.

4. The orificed check valve to be installed in each **DDO/RRII** foot jack circuit will be provided by Fletcher free of charge (see drawing 18-97-7/A for RRII or drawing 20-97-10/A for DDO).
