# IMPORTANT SAFETY NOTICE

## INFORMATION BULLETIN NO. 21

**TO: OWNERS AND OPERATORS OF FLETCHER MODEL DDO AND DDJ ROOF DRILLS**

**SUBJECT: FRONT END LIFT ARRANGEMENT ON MODELS DDO AND DDJ**

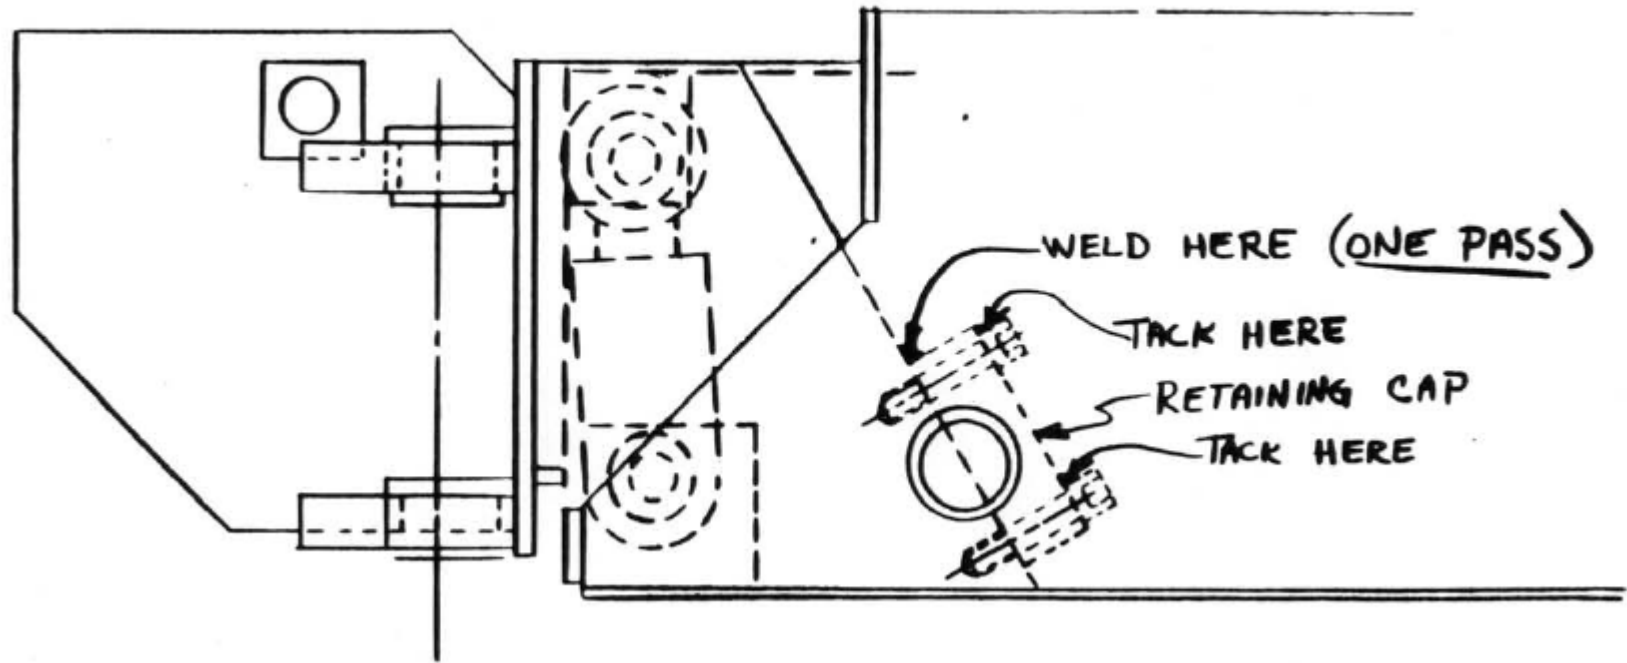
WELD AREAS FOR RETAINER

The allen head screws in the retaining cap for the bronze bushing begin to back out after continued use of the front end lift system.

To prevent this occurrence, tack weld the allen head screws along with welding the retaining cap to the pivot plate.

See the attached drawing.
