IMPORTANT RETROFIT NOTICE

INFORMATION BULLETIN NO. 3

TO: OWNERS AND OPERATORS OF FLETCHER DDO ROOF DRILLS

SUBJECT: CHANGES IN DESIGN OF DDO FRONT END LIFT SYSTEMS

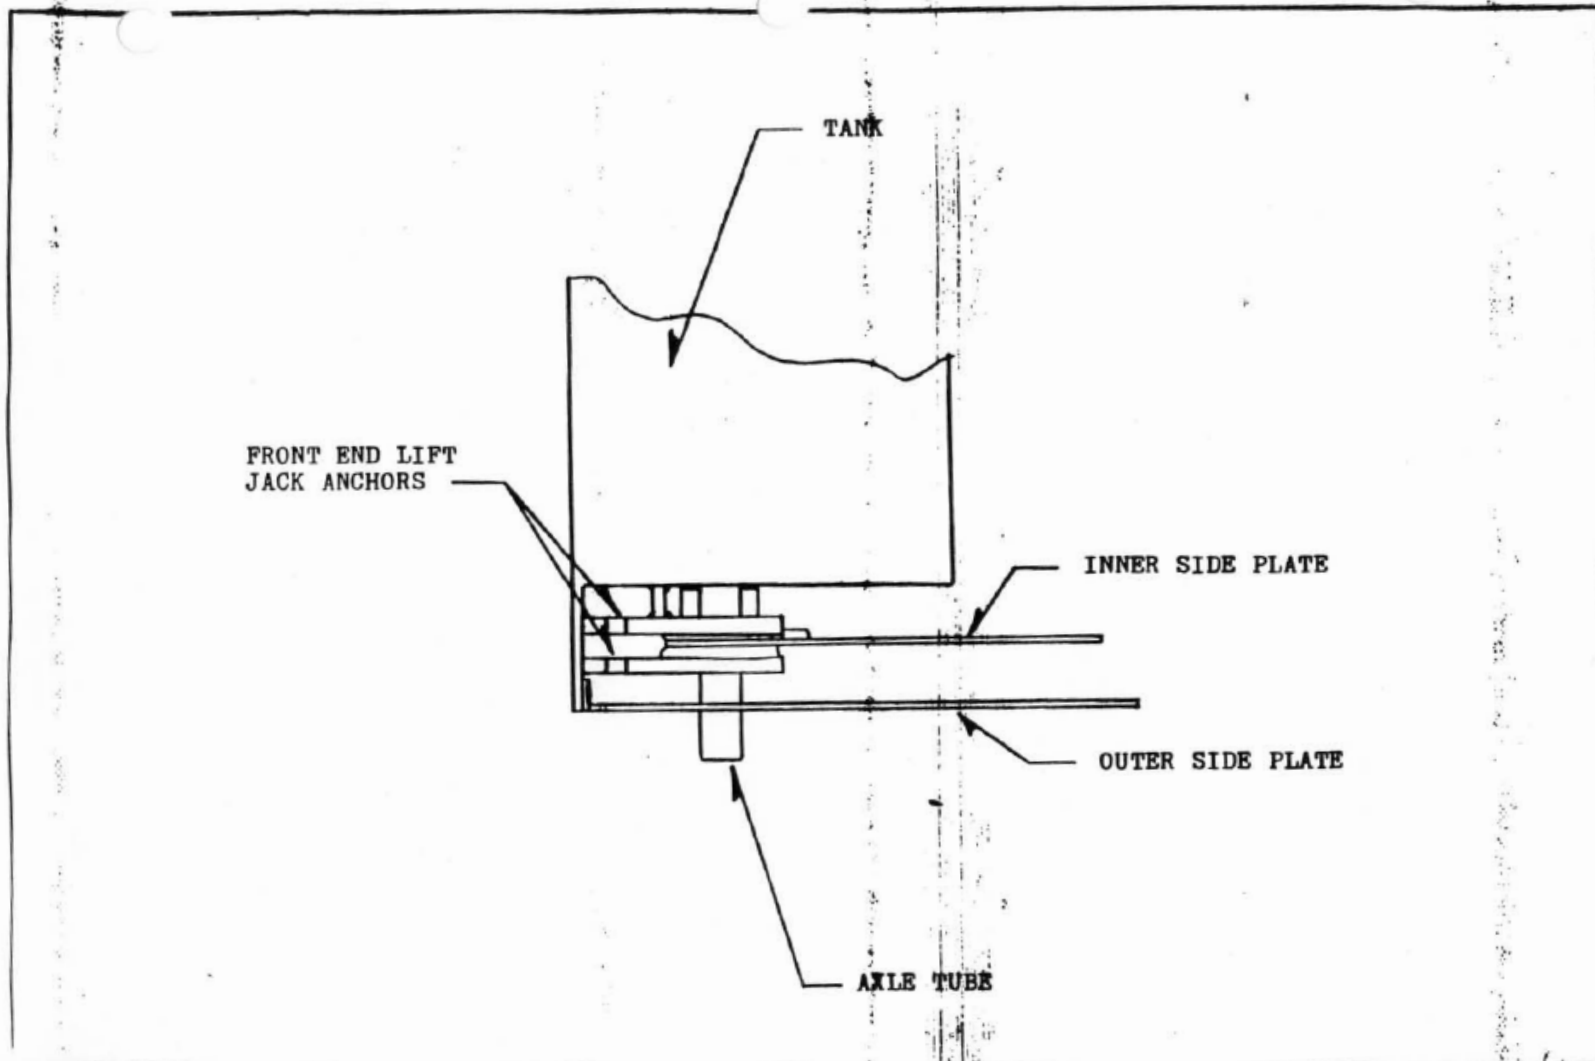
SHEET NO. B0003-1	TITLE FRONT END LIFT - OLD ARRANGEMENT	DATE 6-22-84	R	J. W. FLETCHER & CO. 707 WEST 7TH STREET HUNNERSVILLE, W. VA.
-----------------------------	--	------------------------	----------	---

This improvement involves the manner in which the load is transferred from the jack anchors to the chassis. The original design (see sheet no. B0003-1) put the load directly on the bottom plate of the chassis through the 2" thick jack anchors. A vertical plate was welded onto the back edge of the jack anchors and tied into the side of the oil tank. With this arrangement, high stresses would occasionally occur in the frame bottom plate and/or oil tank.

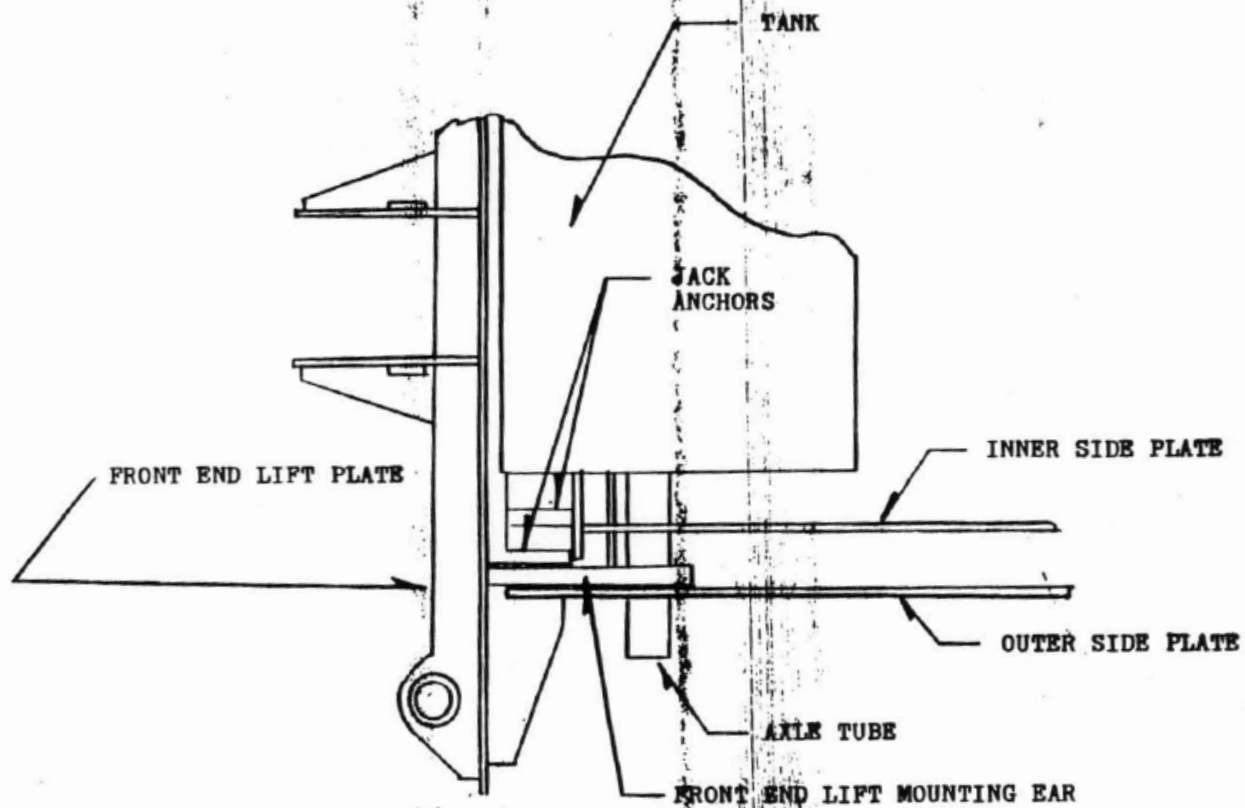
SHEET NO.
B0003-2

The new design (sheet no. B0003-2) transfers the load from the front end lift cylinders further back on the bottom plate of the chassis, around the axle tube, and into the inside chassis side plates.

Retrofit to this new design involves removing the front end, burning out the original jack anchors, welding in the new jack anchors and plates, and reinstalling the front end onto the chassis.

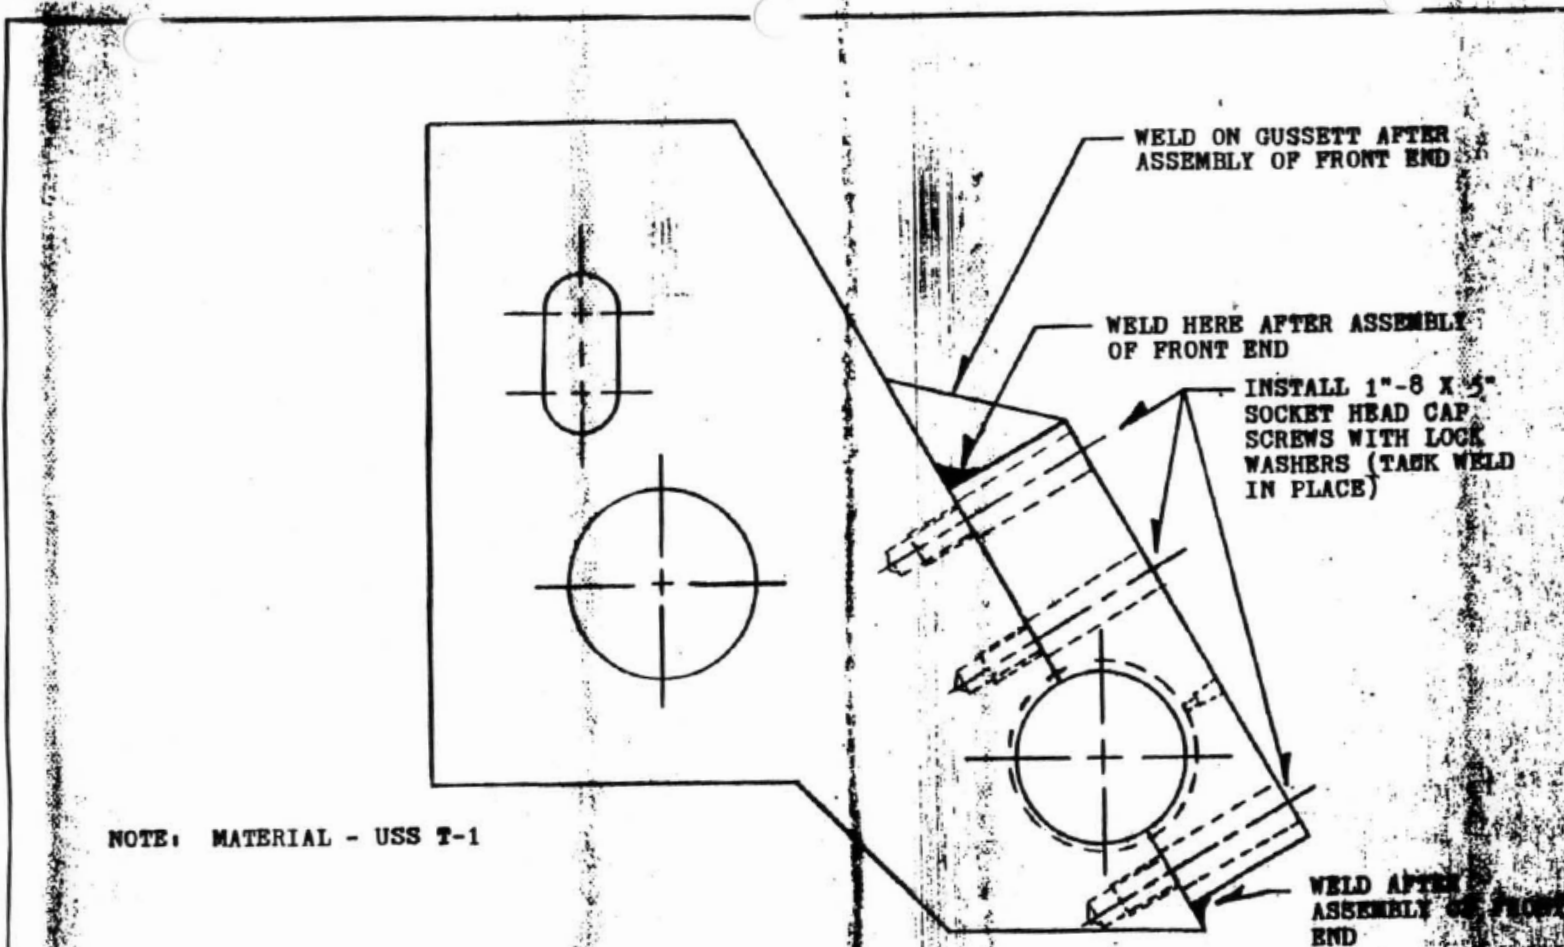
SHEET NO. E0003-3	TITLE FRONT END LIFT MOUNTING BAR ASSEMBLY	DATE 5-22-54	R	J. N. FLETCHER & CO. 707 WEST 7TH STREET HAWAII
----------------------	---	-----------------	---	---

The original design utilized two bolts to secure the retainer cap to the ear. The new design (see sheet no. B0003-3) used three bolts which are tack welded in place, plus a gusset plate between the retain and the ear on the top side.

Retrofit to this new design requires removing the front end, burning off the original mounting ears, welding on the new mounting ears, and reinstalling the front end assembly onto the chassis.
