IMPORTANT SAFETY RETROFIT NOTICE

INFORMATION BULLETIN NO. 32

**TO: ALL OWNERS, OPERATORS AND REBUILDERS OF
FLETCHER DD TRACK DRILLS WITH ELEVATING BOOMS**

SUBJECT: BOLTS ON BOOM SWING TURNTABLE

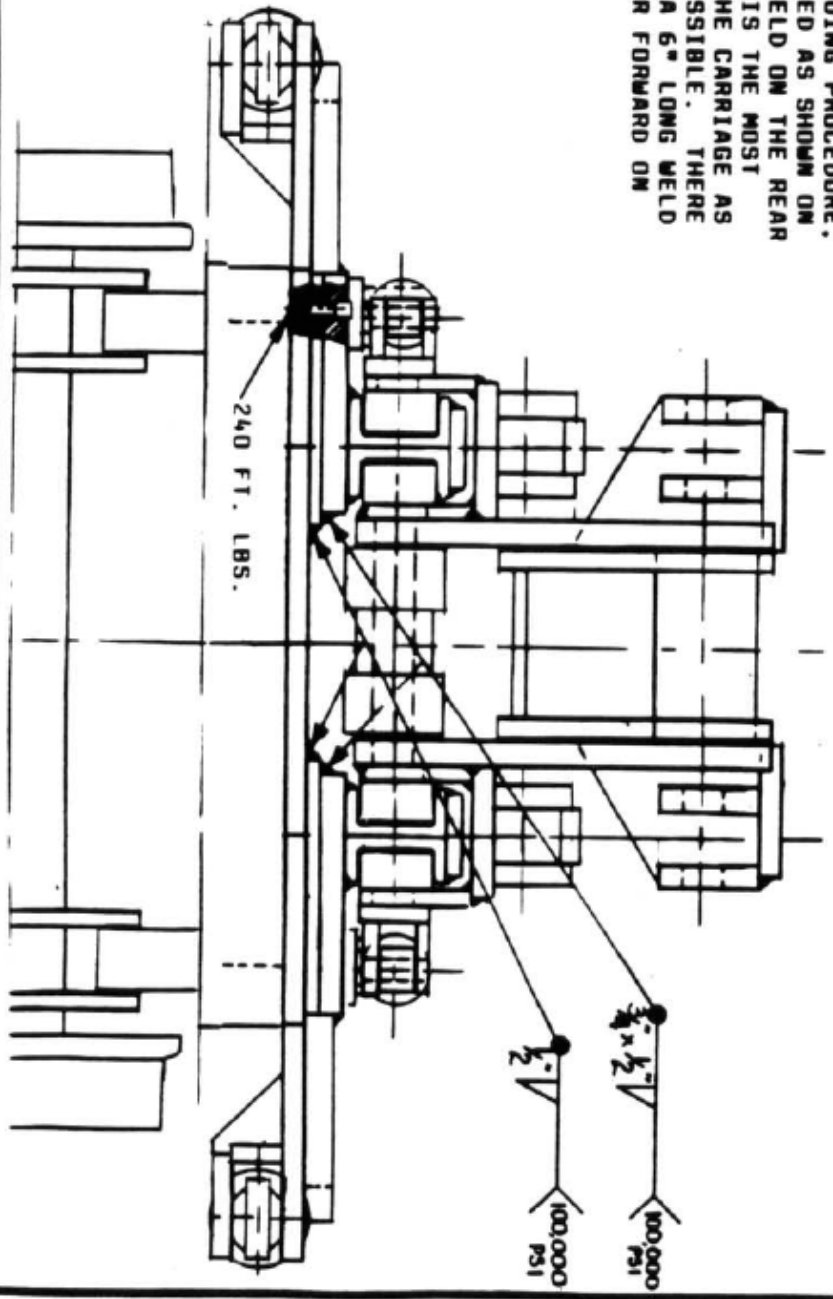
(ROTEK BEARING)

PROBLEM: Bolts holding the boom swing turntable to the slewing ring (or bearing) may break, allowing the boom to drop.

BACKGROUND: The boom swing turntable is made up of three layers of plates. On several machines these plates were not welded together. As a result, the bolts under the back of the boom, between the sump assembly and the turntable, are subjected to an excessive tensile load which could cause the boom to drop.

IF CARRIAGE MOUNT IS NOT WELDED AS THE DRAWING BELOW NOTES THEN USE THE FOLLOWING PROCEDURE:

REPLACE ALL 5/8-11 x 4" (14) SOCKET HEAD CAP SCREWS AND TORQUE TO 240 FT. LBS. (CHECK TORQUE ON REMAINING BOLTS TO THE SAME TORQUE VALUE). AFTER COMPLETION OF BOLT EXCHANGE AND TIGHTENING PROCEDURE, WELDING IS REQUIRED AS SHOWN ON DRAWING BELOW. WELD ON THE REAR OF THE TURNABLE IS THE MOST CRITICAL. SLUMP THE CARRIAGE AS FAR FORWARD AS POSSIBLE. THERE MUST BE AT LEAST A 6" LONG WELD PASS FROM THE REAR FORWARD ON ALL FOUR JOINTS.

240 FT. LBS.
