## INFORMATION BULLETIN NO. 59

**TO:** ALL OWNERS, OPERATORS, AND REBUILDERS OF J. H. FLETCHER & CO. PLATFORM LIFT MODEL HDDR ROOF BOLTING EQUIPMENT

**SUBJ:** MISUSE OF THE PLATFORM LIFT

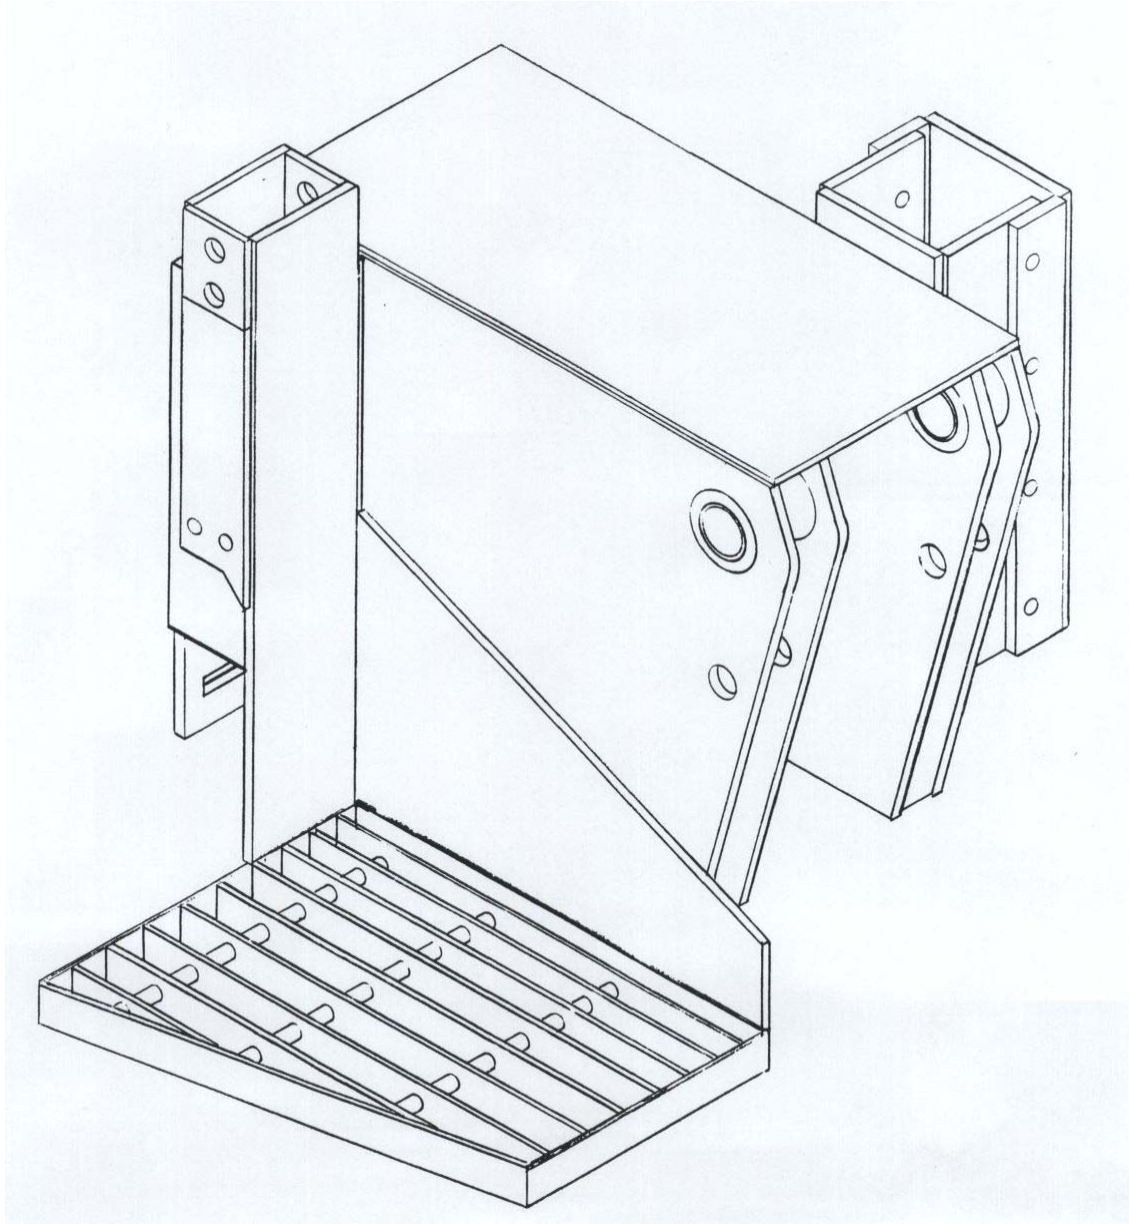
J. H. Fletcher & Co. wishes to inform you of one potentially serious accident that has occurred on an independent platform lift HDDR roof bolter. This accident occurred when a previously damaged driller's platform had been welded to the platform lift housing at the mine site, and the weld apparently failed at the platform to platform lift housing attachment. It is believed that the welding had been required because the operators had left the platform lowered to the floor during tramming and cracked the plate connecting the platform to the platform lift housing.

EXAMPLE OF INDEPENDENT PLATFORM LIFT MODEL  
HDDR ROOF BOLTER INVOLVED IN ACCIDENT

Therefore, J. H. Fletcher & Co. is requesting that all owners of HDDR roof bolters, particularly those with independent platform lift arrangements, check regularly to ensure that the lifting mechanism has not been compromised by this type of misuse. If you have an independent platform lift as shown in the enclosed drawing, check the platform attachment.

J. H. Fletcher & Co. feels if there is a need to lower the platform to the floor, or swing the boom with the platform close to the ground, the operator should be trained to lift the platform before repositioning the machine. Misusing the product could jeopardize the attachment of the platform to the boom or affect the lifting capabilities of the platform.

To prevent serious injury or death, J. H. Fletcher & Co. requests that all HDDR owners check the platform lifts to ensure they are working properly, and to make this part of the machine maintenance program. The accident occurred on a particular HDDR with independent (of boom elevation) platform lift; however, we are encouraging all customers who own these drills to evaluate the condition of their equipment.
