J. H. FLETCHER & CO. Box 2187 – Huntington, WV 25722-2187 – 304/525-7811 – FAX 304/525-4025

INFORMATION BULLETIN NO. 115

TO: ALL OWNERS OF J.H. FLETCHER & CO. NEW AND MODERNIZED MACHINES PURCHASED SINCE JULY 2009

SUBJECT: GROMMETS USED IN MCI LIGHT PACKING GLANDS

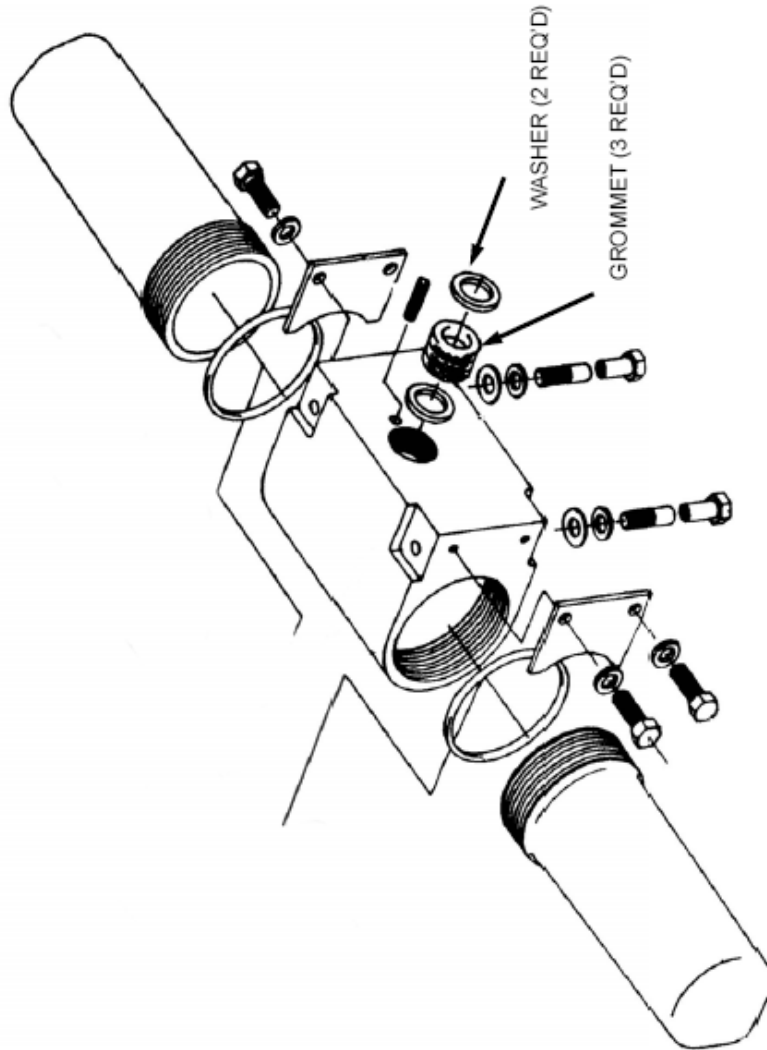
ATTACHMENT 3

Enclosed is a breakdown sheet of the light fixture to indicate the location of the grommets on the lights (see Attachment 3).

EACH KIT CONTAINS:
60 GROMMETS
40 WASHERS
1 INSTRUCTION SHEET
1 PARTS SHEET

NOTE: EACH KIT CONTAINS ENOUGH MATERIAL TO REPACK 20 GLAND ASSEMBLIES.
