Fletcher

Product
Newsletter

September 1997

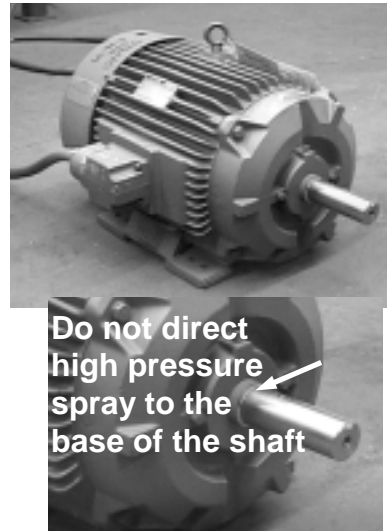
Although the various electrical enclosures (electric motor, lights, starter box, etc.) are permissible - they are not waterproof. During operation the electric motors, lights and starter box will generate heat. If cold water is sprayed onto these components while they are still hot the air inside will be cooled which will create a vacuum that can draw water inside the component.

Electric motors suffer the greatest damage. Water is drawn in around the shaft and into the bearings, corrosion and bearing failure soon follow. To prevent this problem, always allow the machine to cool before washing.

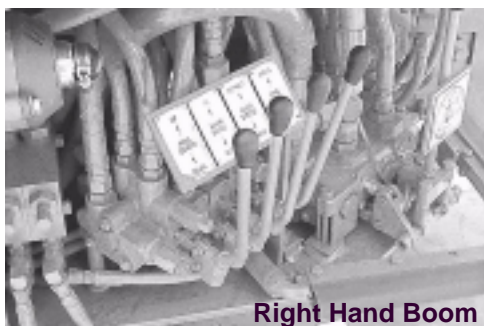
Right Hand Boom
Gresen Valve

Although the Gresen valve bank performed adequately, the relatively small valve spools and control handle assemblies associated with this valve bank were felt to be a maintenance problem by some customers.

To eliminate these spool and handle assembly problems we decided to replace the Gresen valve bank with a Commercial valve bank which was integrated

with the existing Commercial valve bank that controlled the drill feed and rotation.

Besides eliminating the spool and handle maintenance problems, this change also eliminated some of the hosing required in this area of the machine.

This change can be made to existing RR-II machines in the field. If you would like additional information please contact your local Fletcher sales or service representative or our Service Department (304) 525-7811

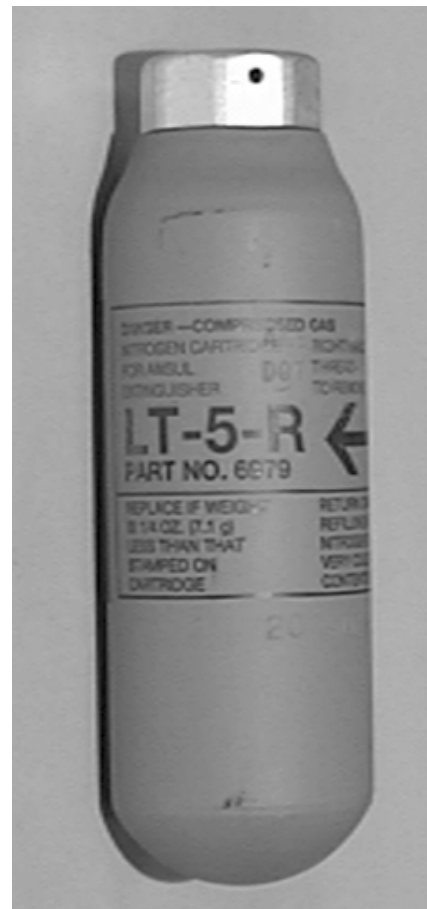
ANSUL Cartridge

Throughout the coal mining industry, gas (carbon dioxide or nitrogen) cartridges are utilized to activate the dry chemicals in fire extinguisher systems. To operate J. H. Fletcher & Co. fire extinguisher systems on our bolters, a nitrogen filled gas cartridge is discharged, usually at the operator's station. This system, if maintained properly, will extinguish a fire located on your equipment. However, the internal seal that prevents the nitrogen from escaping from the ANSUL cartridges could rupture unintentionally, without warning, if they are not installed or stored properly. This accidental activation (rupture) could result in serious injury or death. Therefore, J. H. Fletcher & Co. is reminding our customers that these cartridges are under extreme pressure and that care should be taken at all times during the installation and storage of these pressurized vessels.

J. H. Fletcher & Co. advises you to take steps to ensure all cartridges are stored separately; shipping caps are replaced on the cartridges when they are not attached to the fire extinguisher systems; and that no cartridge is stored at or near a high heat source (direct sunlight, welding, etc.). We advise you to reevaluate the use and storage policy in your shop and take immediate steps to ensure your employees are aware of and trained on the dangers of these small but highly pressurized cartridges. To assist you in your efforts to train your employees, ANSUL has provided J. H. Fletcher & Co. specific information (February 29, 1984, Section III System Components, Technical Bulletin Number 31 and Technical Bulletin Number 34).
