Sufficient Roof Bolt Torque Is Critical

SAFETY NOTICE

**Published by J. H. Fletcher & Co.
Box 2187
Huntington, WV 25722-2187**

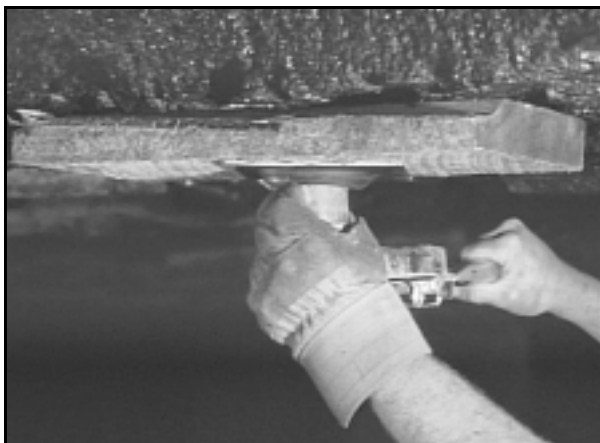
Checking Bolt Torque With Torque Wrench

The only safe means of measuring the torque of an installed roof bolt is to use a hand-held manual

torque wrench. Fletcher does not endorse or recommend the use of machine mounted torque gauges to estimate the torque of an installed mechanical roof bolt. **Machine mounted torque gauges measure only the torque output of the machine, not the torque of the installed bolt.**

The frequency of checking the torque of installed roof bolts is described in the roof control plan. If the torque of the installed bolt is insufficient, the torque out of the Fletcher roof bolting machine needs to be adjusted through the Bolt Tightener and Thrust Relief valve package. Checking and setting the torque output of the machine should only be undertaken by trained and authorized personnel. The Fletcher Service Manual should be consulted. An additional Service Bulletin is also available from Fletcher.

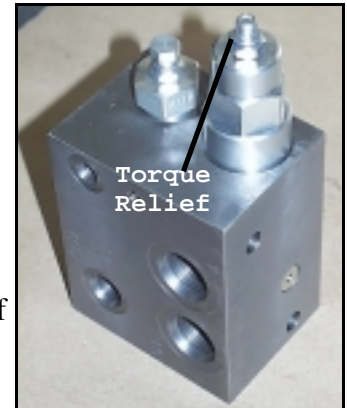
Bolt Tightener and Thrust Relief Valve Package

Never attempt to measure the torque output of the machine or the torque of an installed roof bolt by inserting a torque wrench or any other device into the drill head and stalling the circuit. If attempted, serious injury or death could occur. Make sure the manual torque wrench is properly calibrated to insure proper readings. In high coal, use an appropriate extension to reach the bolt when checking its torque and never stand on the drill head. Failure to achieve and confirm proper torque of installed roof bolts can cause roof falls, serious injury and death.

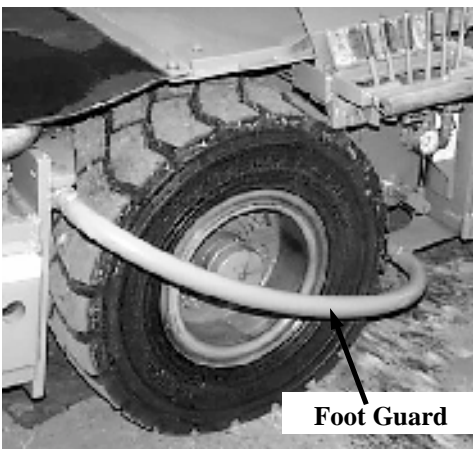
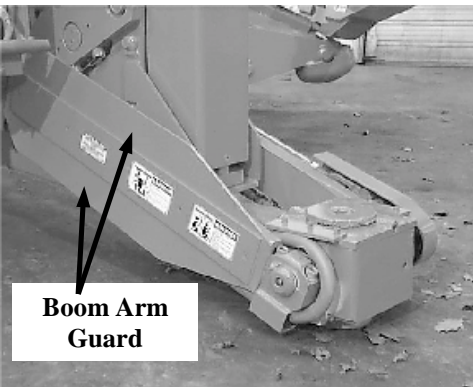
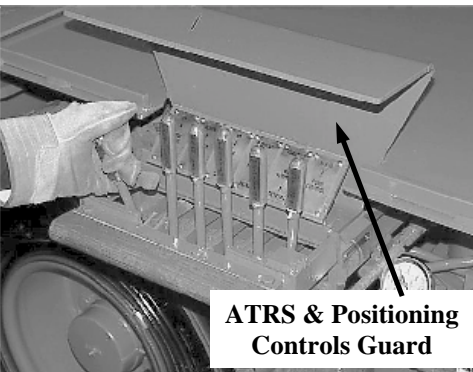
Maintain the Guards

Various machine guards are placed on all Fletcher roof bolters to protect the operator from pinch points, crushing hazards, and inadvertent handle actuation. But these guards are ineffective if they are in poor condition. Inspect the guards every shift to make sure they are secure and not torn or broken. Replace the guards immediately if a problem exists. Guards and warning tags can be ordered from J. H. Fletcher & Co. or an authorized parts distributor.
