# POCKET GUIDE FOR FOOT JACK CYLINDER REPLACEMENT

PART NO. 359293

PUBLISH DATE: NOVEMBER 2004

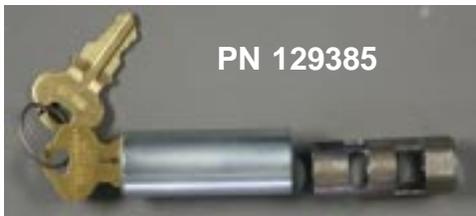
### ARE YOU HAVING PROBLEMS WITH OPERATORS ADJUSTING PRESSURES?

The drill feed package is a complicated valve that restricts or increase hydraulic flow to the drill head. Depending on the needs of the individual mine and the roof strata you are drilling, the valve must be adjusted by trained personnel. Failure to follow the recommended guidelines of the J. H. Fletcher & Co. can expose the operator to: a bent drill steel, a broken drill steel, bit life reduction, and/or inefficient drilling. To prevent untrained personnel from adjusting this valve, J.H. Fletcher & Co. is now offering a key lock kit. The key lock kit (*see photo*) can be installed on the valve to prevent tampering.

The valve lock kit can be ordered from J.H. Fletcher & Co. or one of our authorized distributors (P/N: 129385). If you are having this problem, J.H. Fletcher & Co. encourages you to purchase one of these kits today.

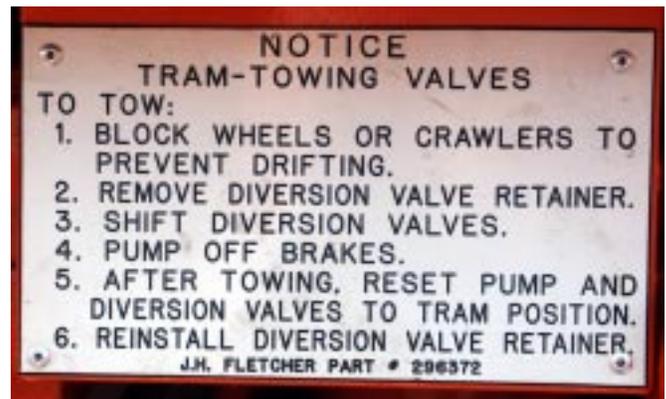
Correct Tag

### TRAM/TOW Tag May Be Incorrect

J.H. Fletcher has recently discovered that a notice tag (part no. 296372) was manufactured incorrectly. The tag, which gives information on tram-towing, was installed on machines with a towing package containing the 36845 diversion valves. Some of the tags read "TO TRAM", and should read "TO TOW". Fletcher believes only a small number of the incorrect tags were installed on machines.

If you have a Fletcher machine with a towing package that includes the 36845 diversion valve, please check the tag to make sure it is worded correctly. If it is not, Fletcher will replace the tag free of charge. Call the Risk Management Department to order a new tag.
