# ROOF SCREENING: BEST PRACTICES AND ROOF BOLTING MACHINES

## ABSTRACT

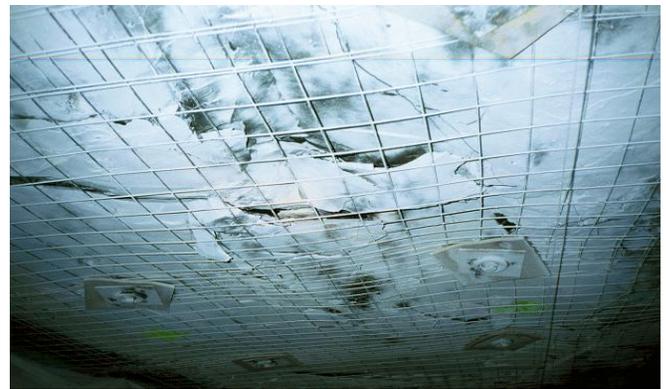
Figure 1. Roof screen effectively controlling weak roof skin.

entry in which it was installed. Some roof is of such poor quality that nothing short of full coverage will provide the best protection. In such adverse conditions, roof screen can provide the necessary protection for miners. Figure 1 shows roof screen effectively controlling weak roof skin.

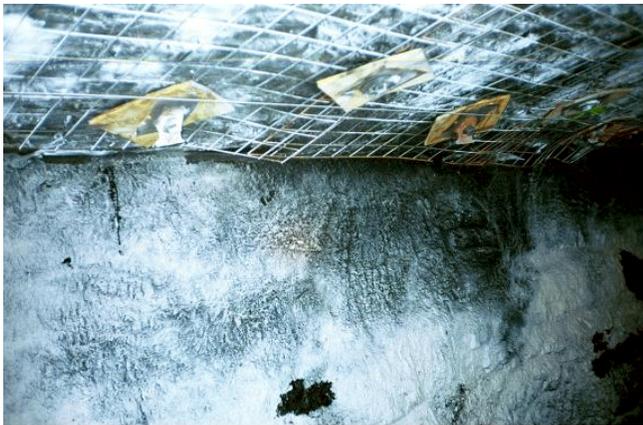
Figure 2. Roof screen achieving up to 94% roof coverage.

While some mines use plastic geogrid screen for surface control, most that are currently roof screening make use of steel wire sheets with a 4-in grid pattern. Screen can be ordered in many sizes depending on the coverage desired or attainable. One problem is that the reach of some bolting units limits how far screen can be bolted toward the rib. A gap may exist between the end of the last bolt and the rib, allowing guttering to occur. To combat this problem, brow tenders (also known as short straps or extended straps) can be used to extend the coverage of roof screen. Bolting machines capable of installing angle bolts also make it possible for the roof screen to be extended further to the rib. Figure 2 shows how roof screen can be supported to within in from the rib. In this figure, 94% roof coverage was achieved by roof screening.

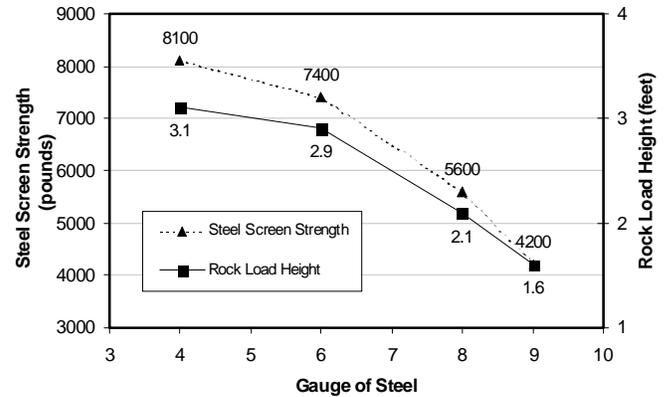
Figure 3. Different strengths and rock load heights for 4 gauges of steel screen.

Besides screen size, sheets can also be ordered in different steel gauge strengths. These strengths (2) along with the rock load height they support are shown in figure 3. The rock density used to calculate rock load height was 162 psf. All the mines visited during this investigation used 8-gauge steel wire sheets with a 4-in grid pattern capable of supporting 2.1 ft of roof skin. This is quite sufficient to contain most skin falls, especially after weathering effects.

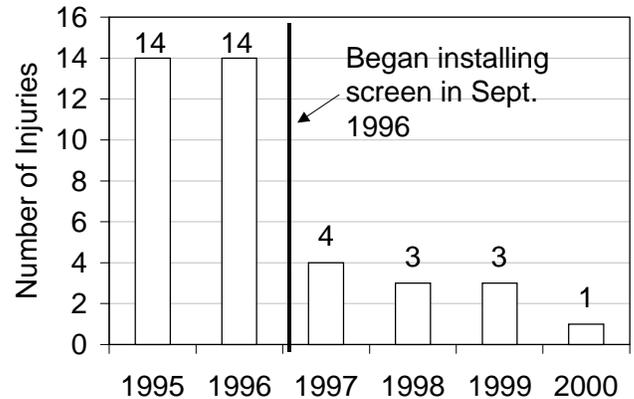
Figure 4. Number of skin fall injuries per year at a northeastern U.S. mine before and after the implementation of screening.

The Mine Safety and Health Administration (MSHA) injury data from two mines was analyzed to determine the effect of screening on safety. One, located in the northeastern U.S., had roof conditions that deteriorated to a point where roof screening was necessary everywhere. After screening was implemented, injuries dropped from an average of 14 to 3 per year (figure 4). At the other, in the central U.S., similar circumstances were encountered that required roof screening. Injuries there subsequently dropped from an average of 7.0 to 0.25 per year (figure 5). Clearly, screening can dramatically reduce rock fall injuries.

It takes an average of 0.42 minutes to handle each piece of screen per 4-ft advance. This time includes operators waiting for and taking the screen from the rib bolter operator, and then placing it across the ATRS. Any adjustment of screen position was also included. The total bolting time for a 4-ft advance, including drilling, installing, maneuvering, setting the ATRS, and screening, was 8.36 minutes. The screening time comprised only 5% of this total. For a bolting advance of 120 ft, screening would add an additional 12.6 minutes. Mine management feels that this is a small price to pay for superior roof coverage and decreased risk of injury (figure 4).

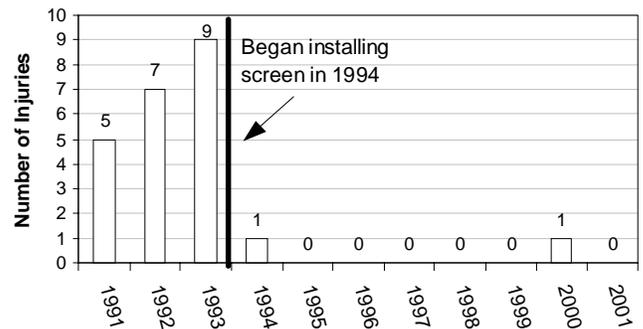
Figure 5. Number of skin fall injuries per year at a central U.S. coal mine before and after the implementation of screening.

due to rock falls dramatically decreased at this mine from an average of 7 to 0.25 per year (figure5).

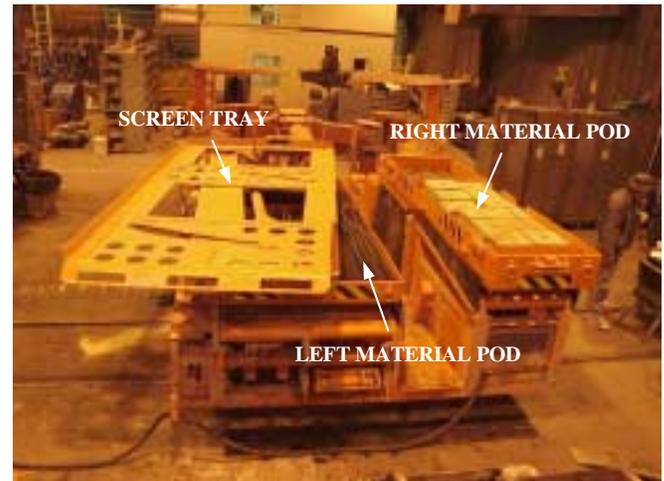
Figure 6. The J.H. Fletcher material handling system: left and right material pods and roof screen tray.

into material pods (figure 6) and then brought into the mine on supply cars. A larger left pod and smaller right pod contains supplies such as bolts, plates, headers, and resin boxes. These pods are also pulled onto the bolting machine by a winch.
