IMPORTANT SAFETY RETROFIT NOTICE

INFORMATION BULLETIN NO. 46B

SUBJ: CLEVIS PIN RETROFIT PROGRAM FOR DRILLING CONTROLS – VALVES ONLY
– PHASE TWO

CLEVIS PIN RETROFIT PROGRAM – PHASE TWO

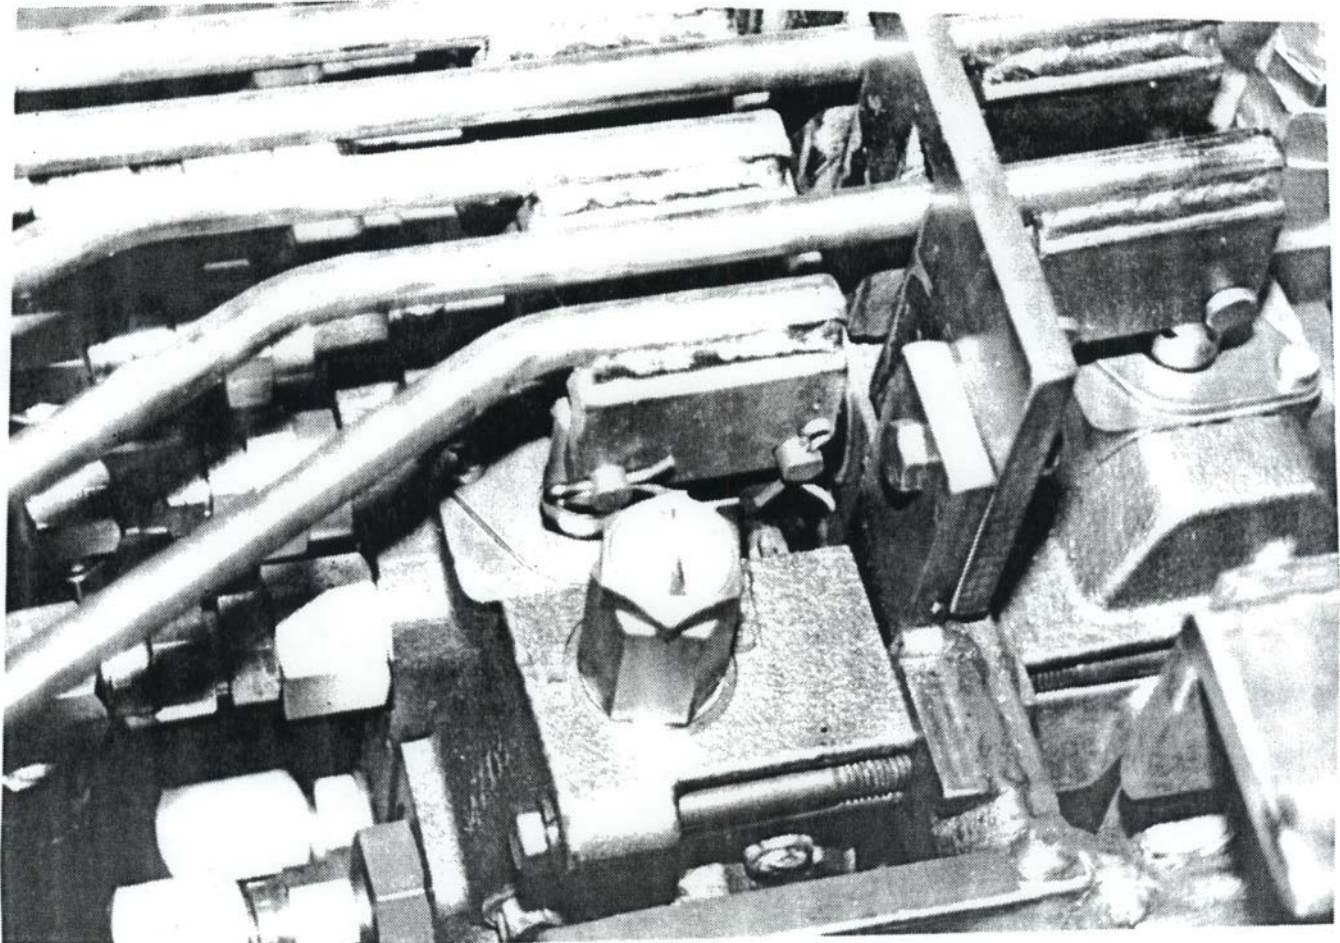
ILLUSTRATION NO. 1

All J. H. Fletcher & Co. Model DDO and RR11 roof bolters manufactured between January 1974 through May 1993, incorporated a clevis pin and a cotter key to hold the handle onto the valve bank (See Illustration No. 1). This system of connecting the valve bank handles with the valve section stem has been used by J. H. Fletcher & Co. for many years without problems.

PHOTOGRAPH SHOWING OLD APPLICATION

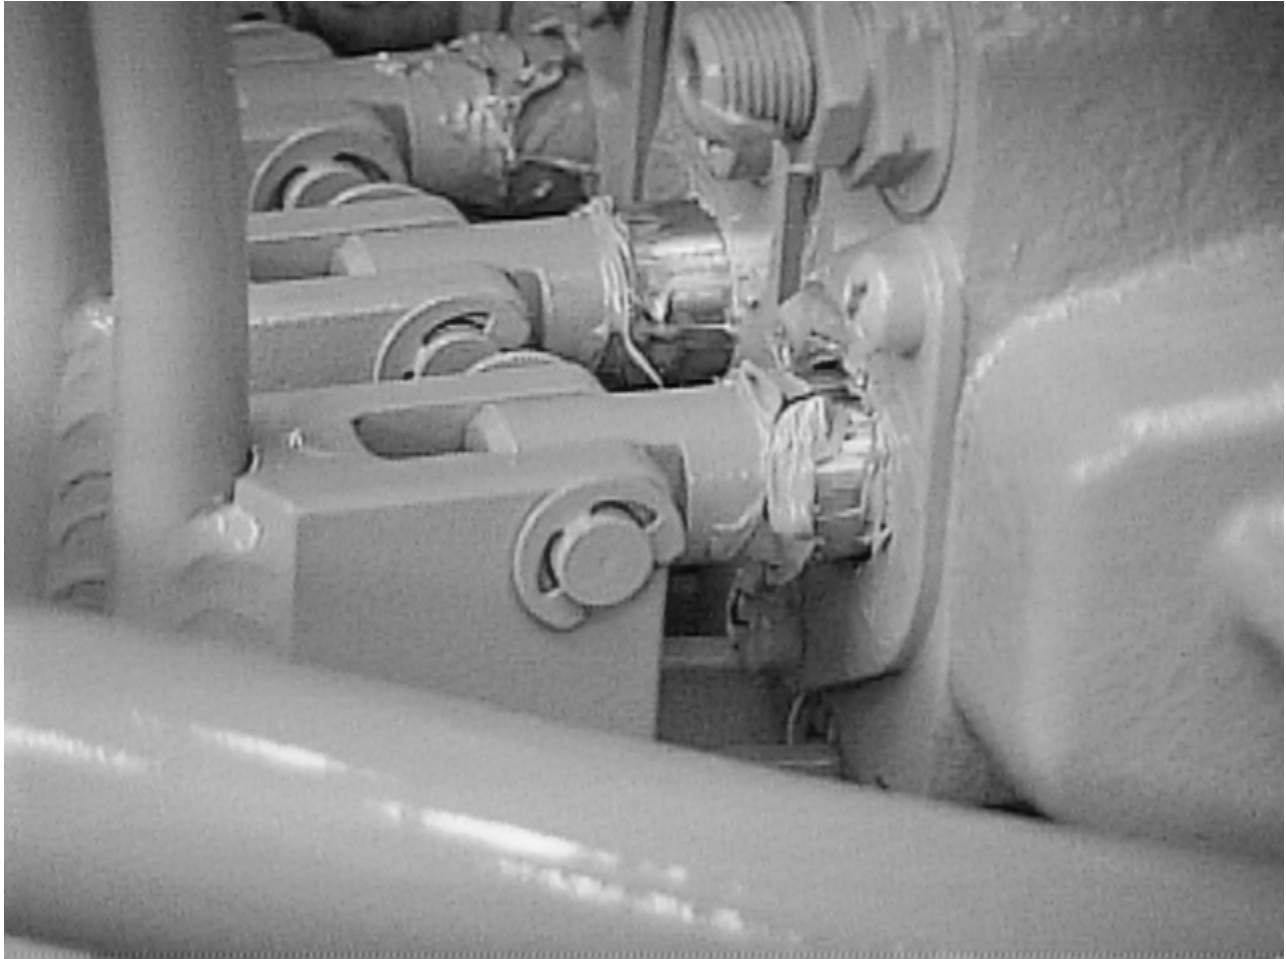
ILLUSTRATION NO. 2

Recently, J. H. Fletcher & Co. discovered that the clevis pin arrangement may cause the rear valve bank handles to stick on cotter pins in the front valve bank of the drilling controls if specific mechanical conditions exist. The cotter key must extend vertically from the clevis pin and the handle must be bent to interfere with this cotter key. In order to reduce this potential risk from the use of this clevis pin arrangement, we are now undertaking a retrofit of the front pins on the forward valve bank (See Illustration No. 2).

PHOTOGRAPH SHOWING VALVE WITH NEW ARRANGEMENT

RETROFIT KIT NO. 159993

If you own a DDO, DTO or RR11 **IMMEDIATELY** contact the J. H. Fletcher & Co. Service Department, COLLECT at 304/525-7811. Provide the serial number(s) for the affected unit(s) and request Retrofit Kit No. 159993. Each kit will be for use on the front valve bank arrangement, which will affect four (4) handles (feed, swing, extend, canopy post) and will require four clevis pins and eight "E" clips for each boom arm.
