IMPORTANT RETROFIT NOTICE

INFORMATION BULLETIN NO. 1

SUBJECT: TRS RAISE CYLINDER EYE

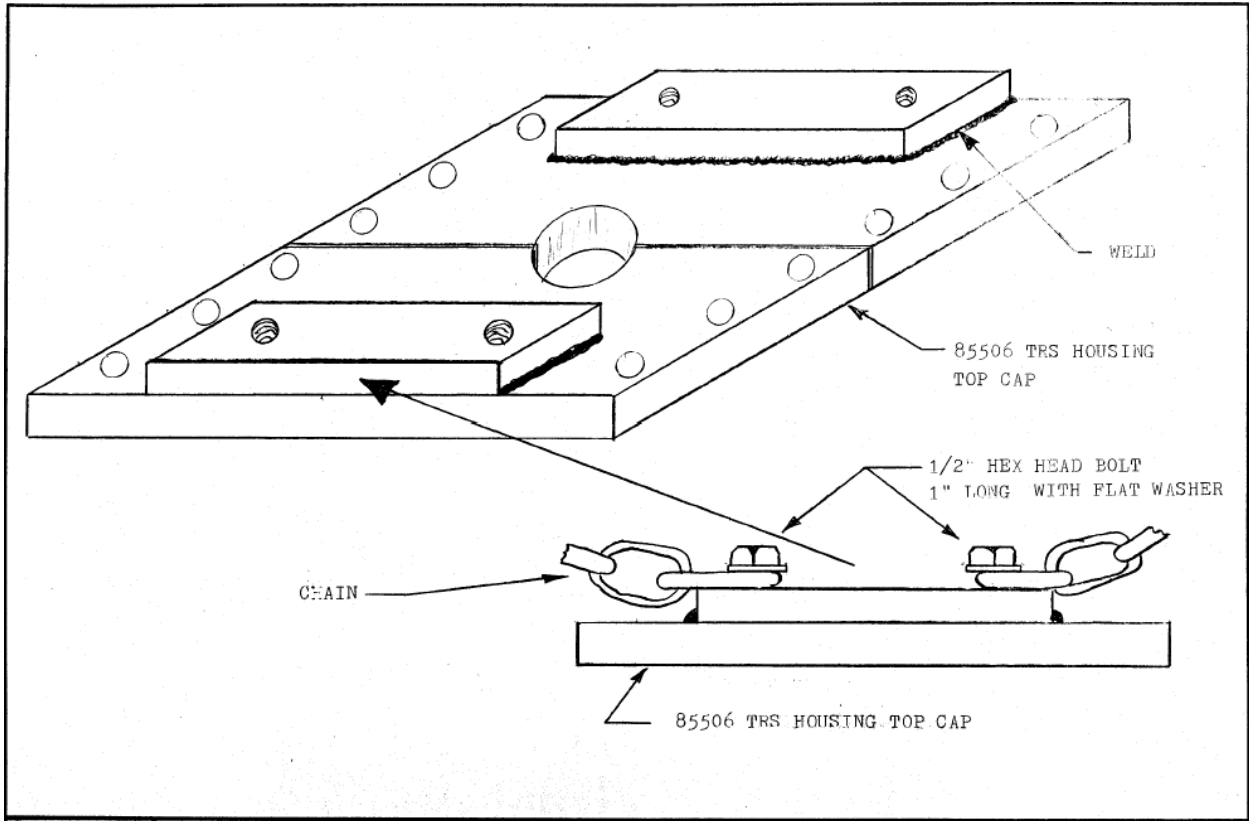
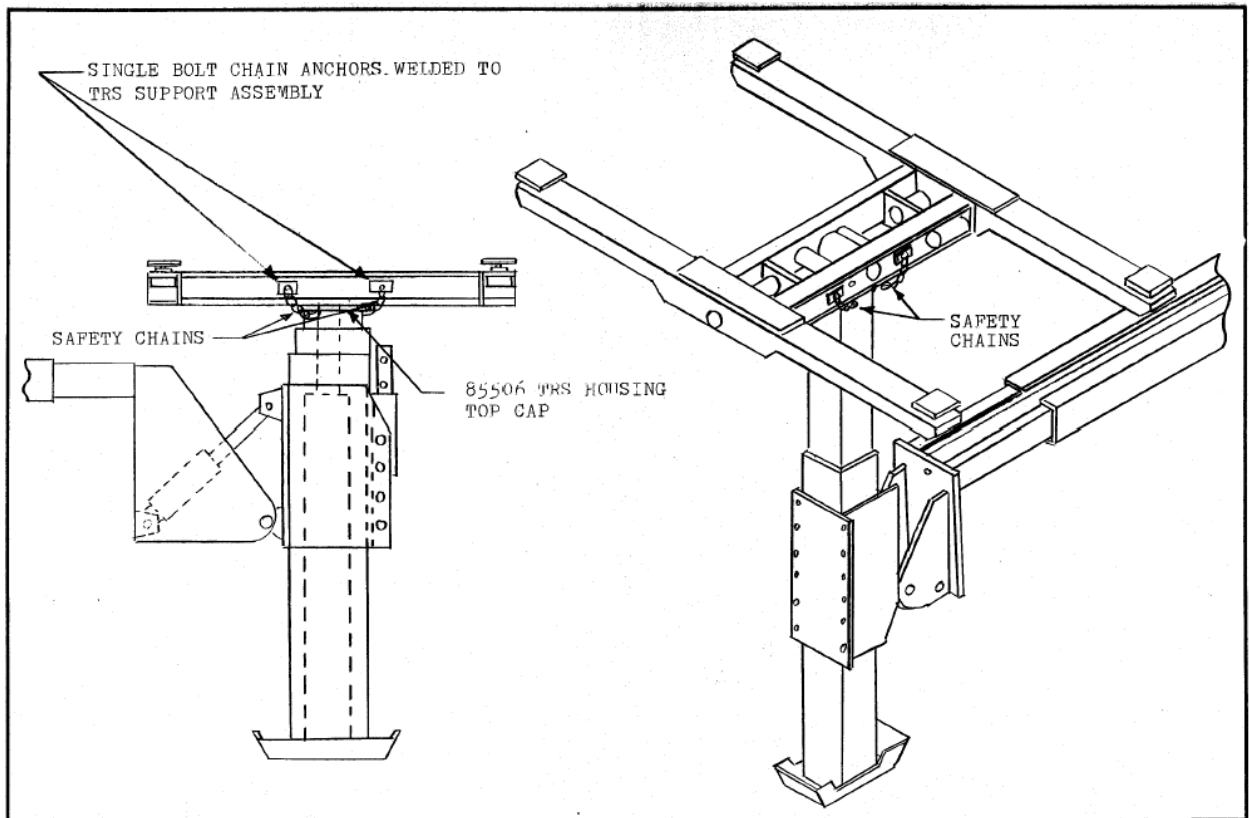
G.M. & W. Coal Company had an occurrence of the TRS raise cylinder eye breaking, allowing the "H" frame assembly to fall to the mine floor.

During normal operation the eye of the TRS raise cylinder should never break. This problem occurs when the TRS is raised to the roof without first being leveled. Operating personnel should be instructed to level the TRS "H" frame assembly before raising it to the roof.

Fletcher Service Representative Bob Miller, along with Steve Gaydos, members of G.M. & W. Coal Company and various government officials, have devised a system of safety chains to prevent the "H" frame from falling in the event the TRS raise cylinder eye should break. These safety chains should be installed between the TRS "H" frame and the top cap of the TRS raise cylinder housing.
