IMPORTANT SAFETY RETROFIT NOTICE

INFORMATION BULLETIN NO. 46A

TO: ALL OWNERS, OPERATORS, AND REBUILDERS OF J. H. FLETCHER & CO. MODEL DDO AND RRII ROOF BOLTING EQUIPMENT

SUBJ: CLEVIS PIN RETROFIT PROGRAM FOR DRILLING CONTROLS – VALVES ONLY

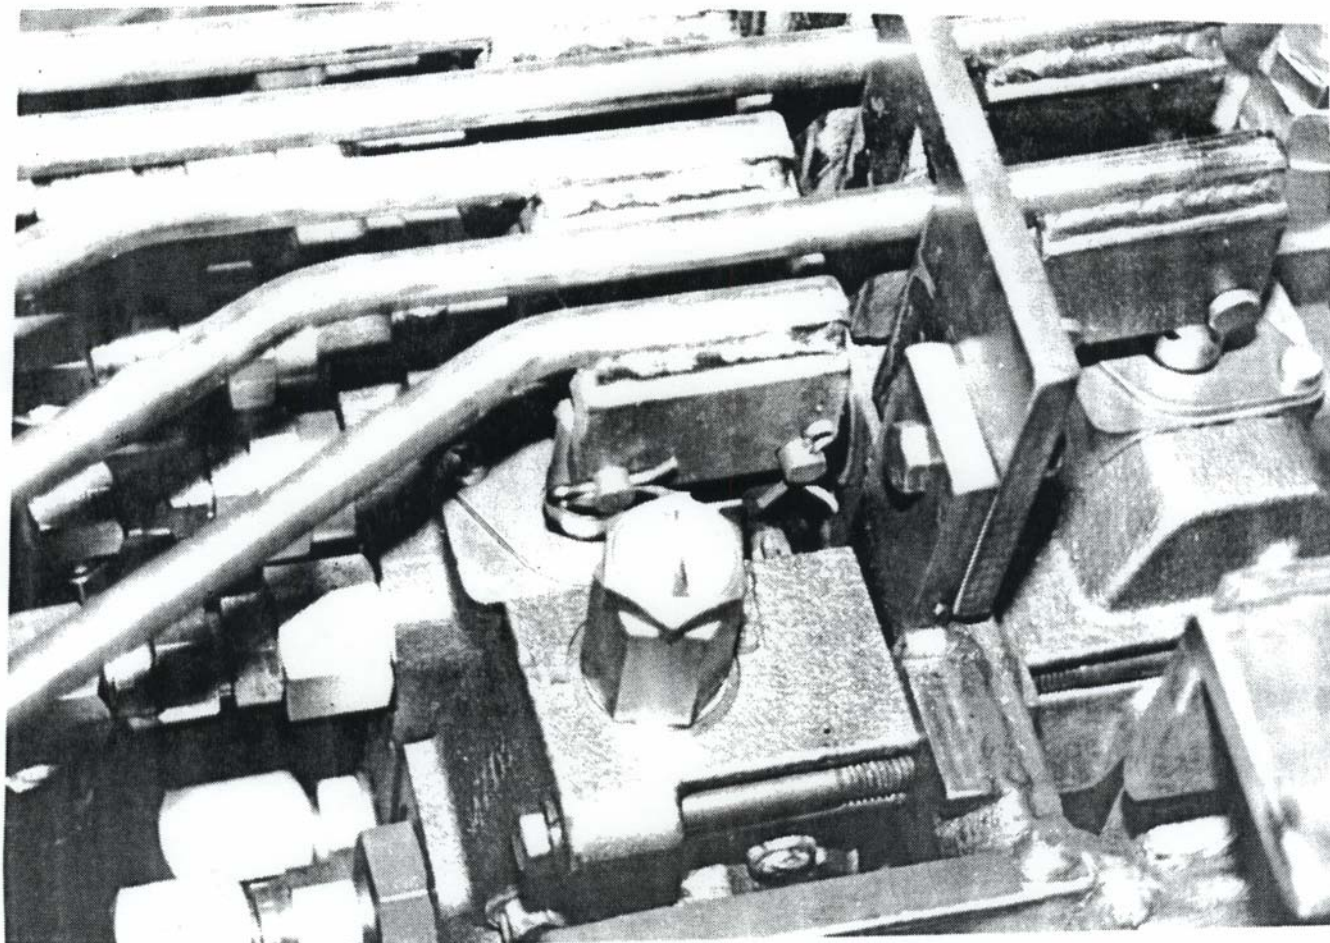
ILLUSTRATION NO. 1

All J. H. Fletcher & Co. Model DDO and RRII roof bolters manufactured between January 1974 through May 1993, incorporated a clevis pin and a cotter key to hold the handle onto the valve bank (See Illustration No. 1). This system of connecting the valve bank handles with the valve section stem has been used by J. H. Fletcher & Co. for many years without problems.

PHOTOGRAPH SHOWING OLD APPLICATION

Recently, J. H. Fletcher & Co. discovered that the clevis pin arrangement may cause the rear valve bank handles to stick on cotter pins in the front valve bank of the drilling controls if specific mechanical conditions exist. The cotter key must extend vertically from the clevis pin and the handle must be bent to interfere with this cotter key. In order to reduce this potential risk from the use of this clevis pin arrangement, we are now undertaking a retrofit of the front pins on the forward valve bank (See Illustration No. 2).
