IMPORTANT SAFETY RETROFIT NOTICE

INFORMATION BULLETIN NO. 47

SUBJ: MODIFICATION OF L-STYLE TRS

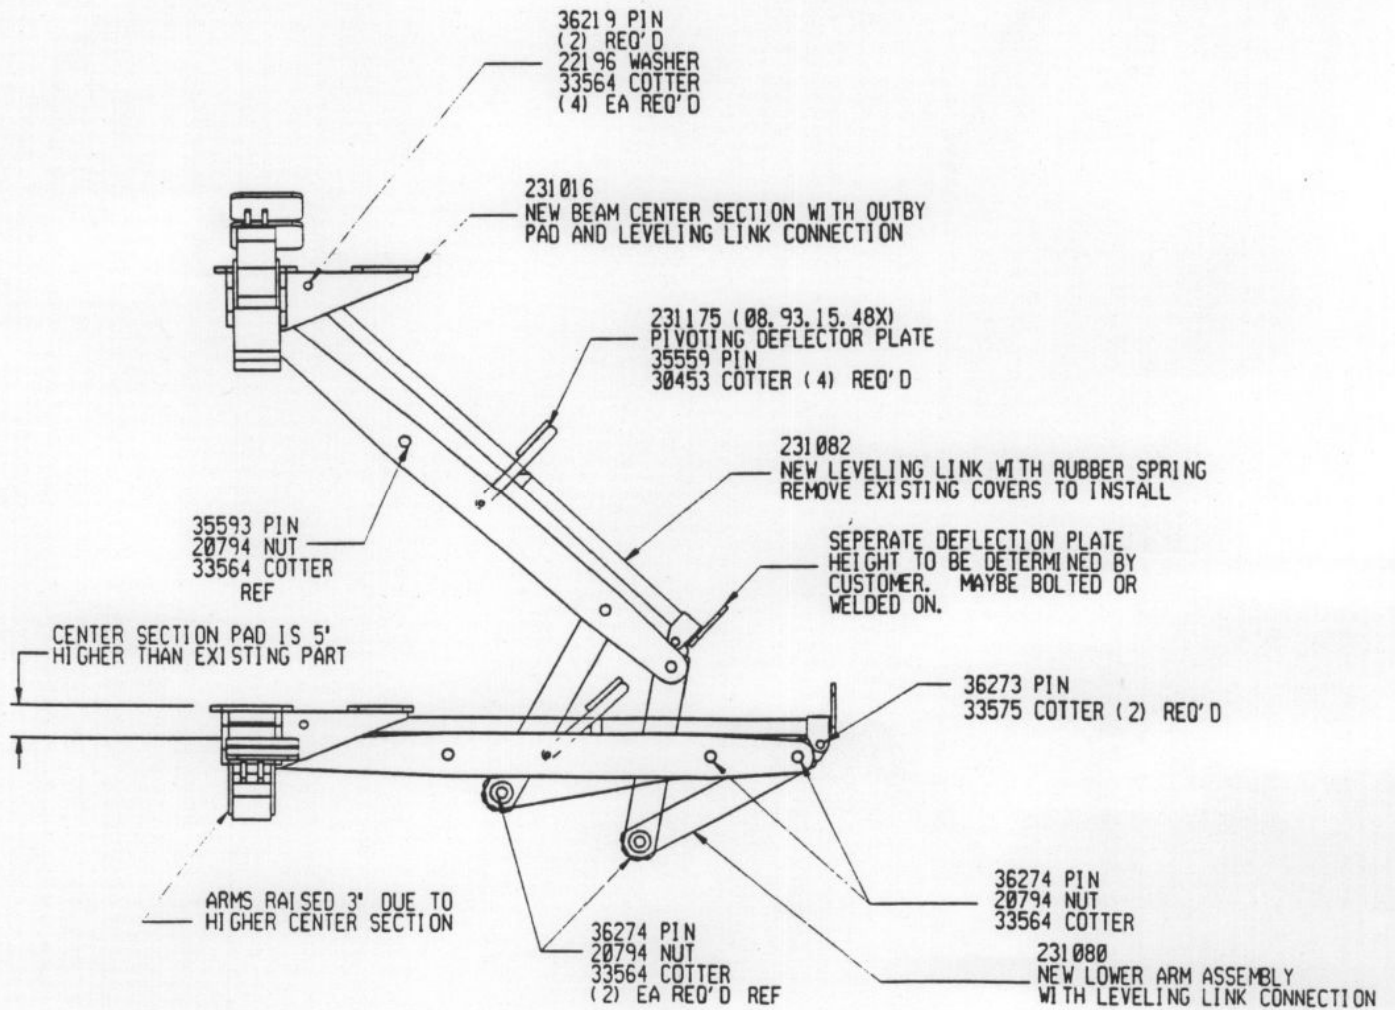
"L" STYLE TRS W/OUTBY

As a result of this potential problem, J. H. Fletcher & Co. has designed a pad attachment which projects from the middle of the TRS beam toward the rear of the machine (see attached drawing). The purpose of this pad is to prevent rocks which break away from the roof in this area from sliding down the TRS arm.

J. H. Fletcher & Co. has been informed of a potential safety hazard caused by roof material breaking loose and sliding down the arm of some L-Style temporary roof supports (TRS). This hazard is associated with specific mine roof conditions and could create a situation that would allow the roof material to slide down the TRS into the operator.

J. H. Fletcher & Co. considers it of vital importance that all owners of walk-thru inside control machines with a L-Style TRS evaluate their mine roof conditions immediately to determine if this retrofit is necessary. It is J. H. Fletcher & Co.'s position that this retrofit will decrease the possibility of injury to operators.
